Review
Of
Gasoline Cargo Tank Truck
Pressure Performance
Test Procedures

MONITORING AND LABORATORY DIVISION VAPOR RECOVERY IN-USE PROGRAM SECTION

DATE: March 19, 2008

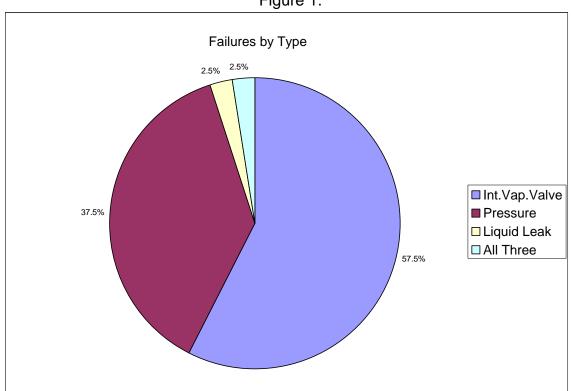
Figure 1.

A total of 292 cargo tanks were tested by ARB ED at the loading racks, using TP-204.2 and TP-204.3, of which 40 failed to comply with the leak rate standard. Each of these 40 cargo tanks were cited by ED and issued NOV. Table 1 and Figure 1 provide a breakdown of the types of failures during the study period.

Note: "All Three" refers to a single cargo tank with a pressure leak, internal vapor valve leak and a liquid leak all at the same time.

As shown in Table 1 and Figure 1, most of the failures were due to leaking internal vapor valves. As discussed previously, only one of the cargo tanks was issued a NOV for a leak that was not subsequently detected back at the repair facility prior to any repairs. Thus, the issues of concern by industry were, for the most part, not observed in this study. However, as discussed in the conclusions below, we did observe several situations which may explain why the frequency is perceived by industry to be higher than what was observed in this study.
